Field observations and numerical studies of horizontal stress effects on roof stability in US limestone mines

by G.S. Esterhuizen*, D.R. Dolinar*, and A.T. Iannacchione*

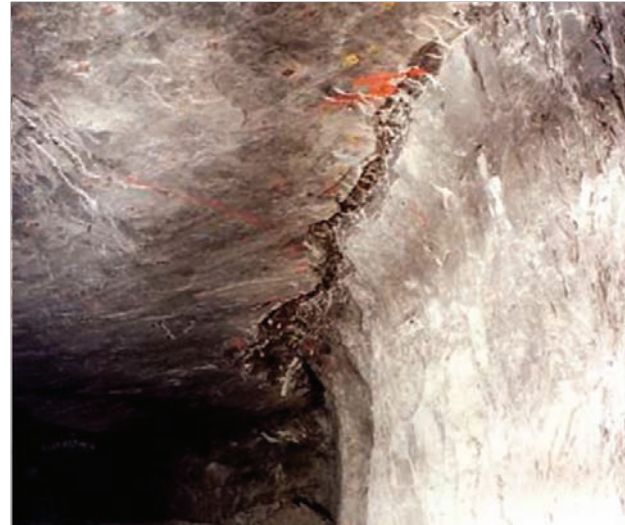
Figure 2—Roof guttering at the pillar-roof contact

Horizontal stress related damage can manifest itself as guttering along the pillar-roof contact area^{6,19} as seen in Figure 2. This is very similar to ‘cutter roof’ seen in coal mines that are subject to high horizontal stresses. Once the roof has been damaged at the pillar contacts, the confining stresses are relieved and the immediate roof layers can fail. The failure can extend across the width of the excavation if it is not well supported. This type of failure has been observed in mines located in both inclined and flat lying limestone formations.

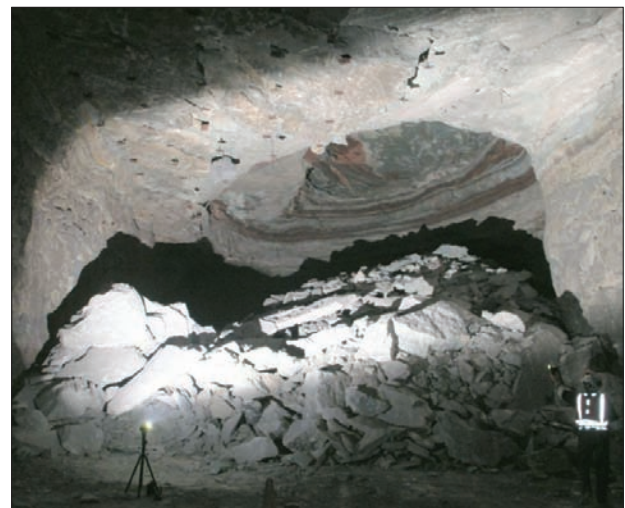
Figure 4—Large-oval shaped fall that has propagated upwards into weaker overlying strata in a limestone mine
